PHASE I ENVIRONMENTAL SITE ASSESSMENT

26555 Northwestern Highway | Southfield, Michigan PM Project Number 01-7009-0-0001

Re: Phase I Environmental Site Assessment of the Office Building

Located at 26555 Northwestern Highway

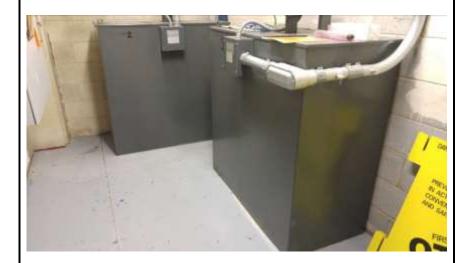
Photograph 19

General interior view of elevator equipment

Elevators: Seven hydraulic lift elevators are located at the subject property, with five elevators installed between 1967 and 1969 and two elevators installed in 1981. Because five of the units were installed prior to 1978 (the USEPA banned the manufacturing of PCB-containing hydraulic fluid in 1976, and the manufacture of PCBs ceased in 1977), PM is of the opinion that the elevator's hydraulic fluid potentially contains PCBs. No visual indication of leakage was observed in the area of the elevator operating equipment. The hydraulic elevator units at the subject property should be inspected periodically for leakage as part of the on-going maintenance activities. If leakage is identified, the unit should be repaired, and any fluid or fluid-soaked waste should be disposed of in accordance with applicable federal, state, and local regulations.

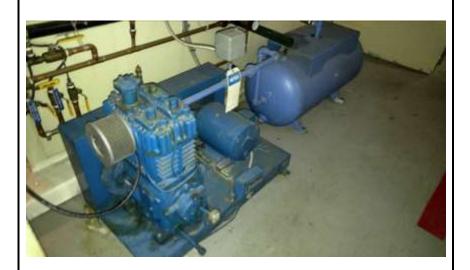
Photograph 20

General interior view of an air compressor

Air Compressors: PM observed one air compressor in the mechanical room and one air compressor in a storage area in the basement. The air compressors were in good condition and staged on concrete in good condition. The storage area compressor discharge hose was not visible, and limited staining was observed on the concrete at the base of the compressor; however, the concrete floors were in good condition with no cracking, pitting, or damage observed. The mechanical room compressor discharge hose was not visible, and the compressor was marked as a back-up unit, with no staining or evidence of poor waste management practices observed in association with the compressor. Based on the observed conditions, PM has not identified the air compressors as a REC. However, PM recommends the storage area air compressor fluid be discharged to a container, and the fluid disposed of in accordance with local, state, and federal regulations.

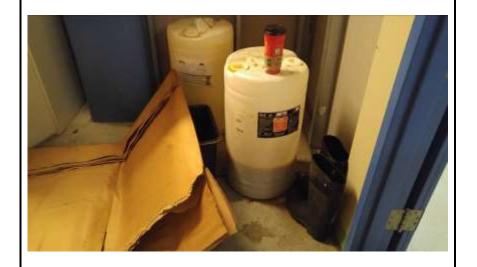
Photograph 21

Interior view of two 30-gallon partially filed degreasing cleaner drums in a basement storage area

Drums, Barrels, and/or Containers > 5-gallons: PM observed two 30-gallon partially filled degreasing cleaner drums and one 30-gallon partially filled drum (contents unknown) located in a storage area in the basement. The drums, which were staged on concrete and not stored in secondary containment, were in good condition with no evidence of leaking and/or staining observed on the drums or on the concrete floors in the vicinity of the drums. Based on the observed conditions, PM has not identified the drums as a REC. However, PM recommends the drum with unknown contents be properly characterized, and each of the drums disposed of in accordance with local, state, and federal regulations.

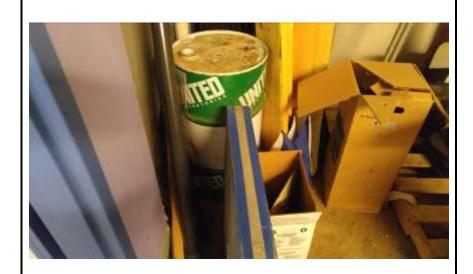
Photograph 22

Interior view of one 30-gallon partially filled drum (contents unknown) in a basement storage area

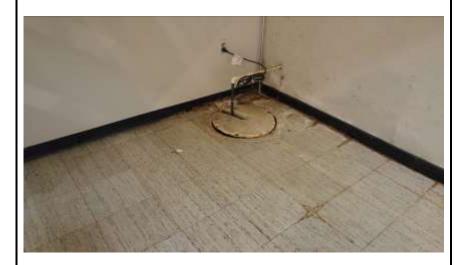
Photograph 23

General interior view of a sump

Sumps or Cisterns: The subject property contains a basement sump and a parking garage sump. The sumps were in good condition with no evidence of staining and/or poor waste management practices observed. Additionally, no hazardous substances and/or petroleum products were stored in the vicinity of the sumps. Based on the observed site conditions, PM has not identified the sumps as a REC.

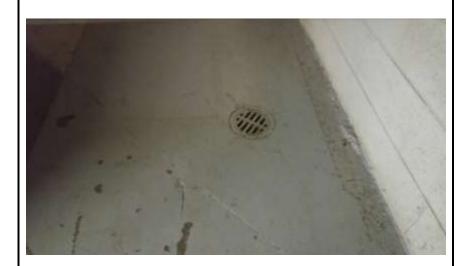
Photograph 24

General interior view of a floor drain

Floor Drains, Trench Drains, etc.: PM observed floor drains in the following areas: kitchen, restrooms, mechanical room, basement, and parking garage. No staining or evidence of poor

waste management practices was observed in association with the drains. The drains likely discharge to the municipal sewer system.

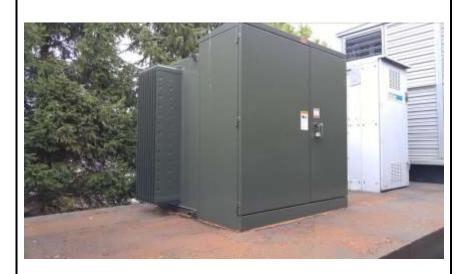
Photograph 26

General view of a pad-mounted transformer

Pad or Pole Mounted Transformers and/or Capacitors: The subject property is supplied with underground secondary electrical service from three pad-mounted electrical transformers, two of which are located in the mechanical room, with one located in the southern portion of the property. The transformers are likely designated as the property of Detroit Edison (DTE), the public utility. The mechanical room transformers are labeled as "Non-PCB;" however, the outdoor transformer is not labeled regarding PCB content. No leakage of the transformers was observed at the time of the site reconnaissance.
